12/3/2020 Site Visit Observations

Attendees: Derrick Fleury (Town of Ticonderoga), Todd Hodgson (Essex County), Roy Richardson (B&L)
Purpose: To evaluate the existing water main location and identify potential areas where the pipe might be able to be reused

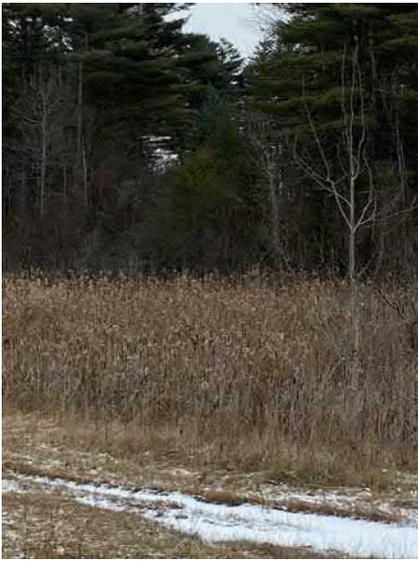
however there is concern over the pipe that is located in the backyards of residents and particularly the stretch that runs through the potential wetland area. Should a break occur, it could be a difficult location to access for repairs due to the wet area. See Figure 1 showing this area.

Figure 1: Existing main is away from the road and is installed through a potential wetlands area. Access to pipe could be difficult and time consuming.

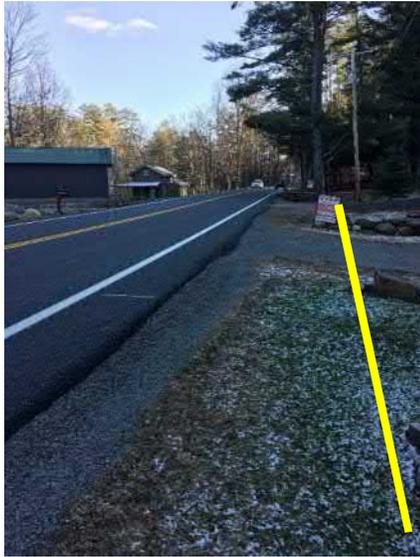
3. Eagle Lake Area – Generally not recommended for reuse
 - a. Figure 2 shows an area at the start of Eagle Lake where potential reuse of the pipe could occur as it is accessible for repairs and has not had many repair issues.

Figure 2: Existing main is on side of road away from lake as generally shown by the yellow line. Pipe in this area is generally serviceable.

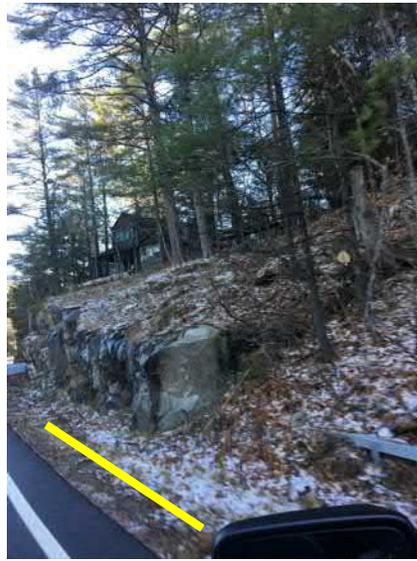
- b. Figures 3, 4, and 5 are very concerning as there is high risk of pipe freezing and/or breaks, without a reliable way to make the necessary repairs in a prompt time frame. The steep drops, proximity to road, narrow lanes, and presence of ledge will make repairs slow, costly, and very difficult for Town crews. This could put residents out of water for an extended period of time while repairs are being made. It will take time to setup cribbing and other means to be able to excavate the pipe and traffic will be down to one lane for the duration of the repair. Traffic is of high concern, as the lanes are narrow with no shoulders. Log trucks traversing this area during a repair might not have sufficient room to get around the construction without either going off of the road or the Town crews reducing their footprint, which is not very feasible. This is a safety risk to the Town employees and the public in general in these narrow areas.

Figure 3: Existing main is on side of road away from lake as generally shown by the yellow line. Pipe in this area is shallow, has rock ledges right against pipe and is anticipated to be a difficult repair.

- c. In the Eagle Lake area, a new pipe could be located in a better location and would be expected to have a significantly lower need for repairs. Although the capital costs would be higher now, it would reduce the risk of costly emergency repairs to the existing pipe and should be considered more viable over the long haul. In addition, a planned construction with advanced traffic warning signs would reduce the frustrations to the public that would occur due to an unplanned repair.

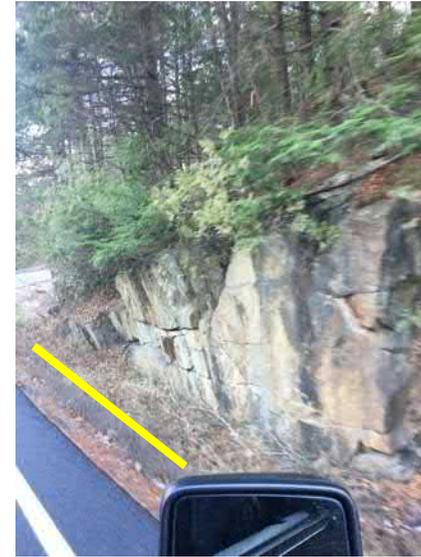
Figure 4: Existing main is on side of road away from lake as generally shown by the yellow line. Pipe in this area is shallow, has rock ledges right against pipe, and a steep drop off from road to culvert, making this a very difficult repair.

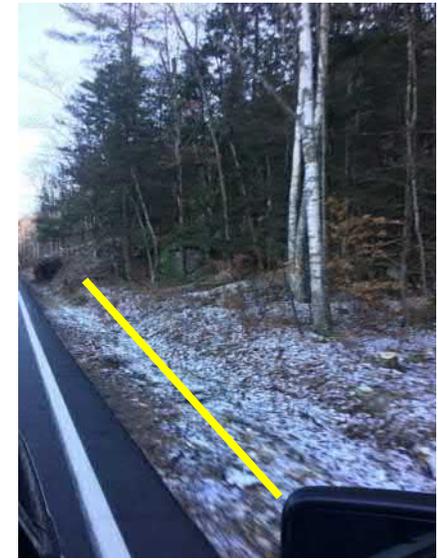
Figure 5: Existing main is on side of road away from lake as generally shown by the yellow line. Pipe in this area is generally serviceable. Anticipate high water in this area from runoff of steep slope, leading to concerns of heaving around pipe.
